Anatomy of an Inherently Dangerous Deck

By Frank Woeste

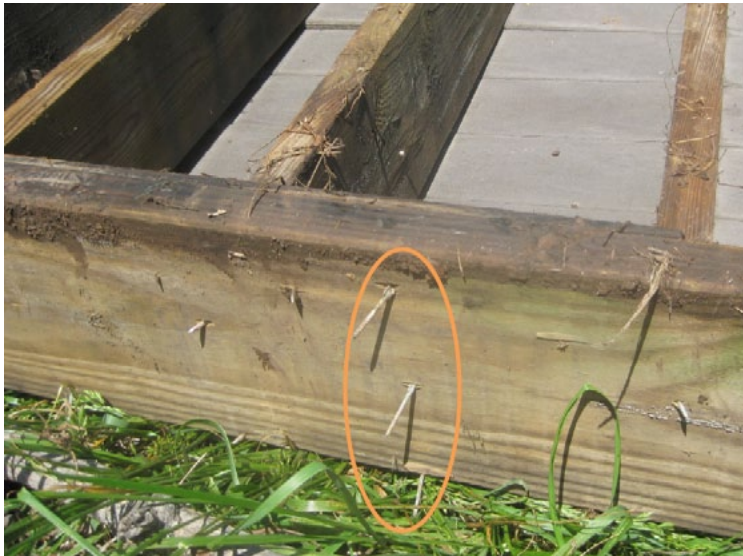
The deck remains shown in Figure 1 depict a case where the deck shifted laterally, away from the structure, and fell to the ground.

Figure 1. Close-up of deck ledger that was connected to a structure with nails only. When lightly loaded by occupants, the deck shifted laterally, pulling the nails out of the supporting structure.

Had the deck fallen vertically at the ledger side of the deck before shifting away from the house, the nails would have bent over. In this case, the nails are essentially straight, indicating that the nails withdrew from the wall before total collapse of the deck floor. Nails used in this application have negligible strength, providing only support for the weight of the deck without sufficient reserve capacity for in-service loading by occupants.

This question can be answered in a few minutes—if *only* nail heads are present on the surface of your deck ledger, you have a nailed-only deck ledger. The deck should be tagged as unsafe, not occupied, and immediately repaired or replaced.

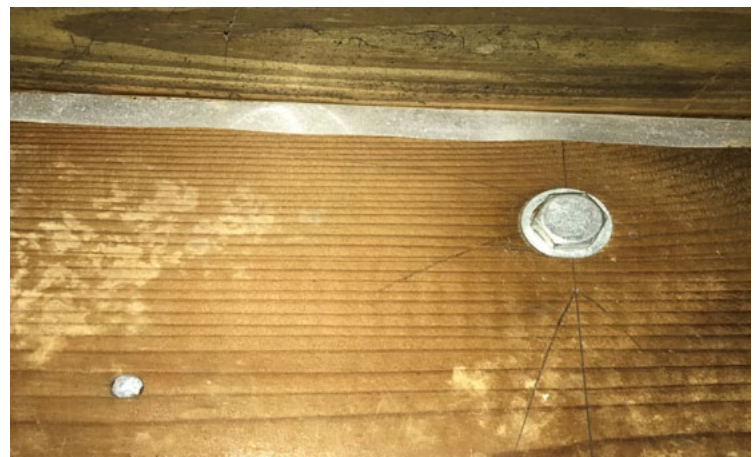
Figure 2. Section of a deck ledger with a nail head and ½” diameter lag screw installed.

The proper lag screw diameter per the IRC can be verified by the fact that 1/2" lag screws have a hex-head that is 3/4" wide. In this case, the contractor used 1/2" diameter lag screws to connect the ledger to the wall sheathing and house band. (The nail (bottom left) was likely used to position the ledger on the wall while the lag screws were installed.)

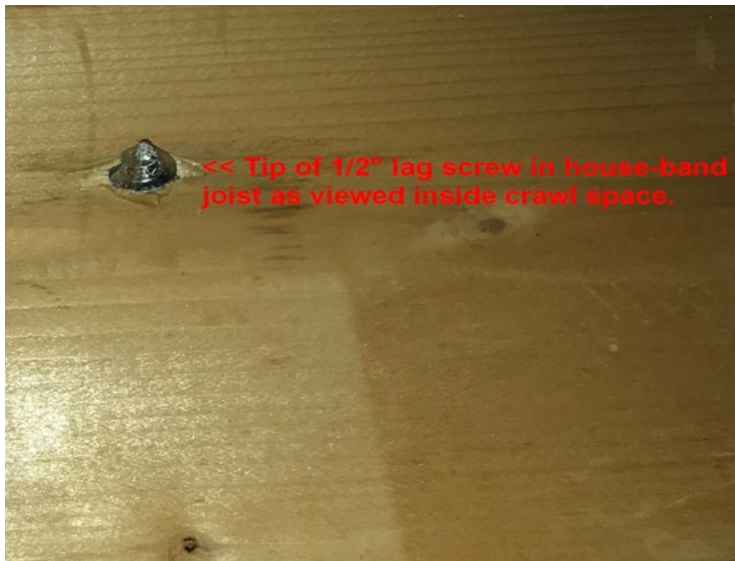
Figure 3. The tip of the lag screw depicted meets the IRC requirement for fully extending beyond the inside face of the band joist.

Because the tip of the screw extends beyond the inside face of the house-band joist, the installed 1/2" lag screw is clearly the proper length as required by the IRC. Assuming the tips of the lag screws are not present, the installation is not

IRC compliant and thus the deck may be unsafe, requiring an investigation by a design professional.
