# ALL THINGS WOOD

## Anatomy of an Inherently Dangerous Deck

By Frank Woeste

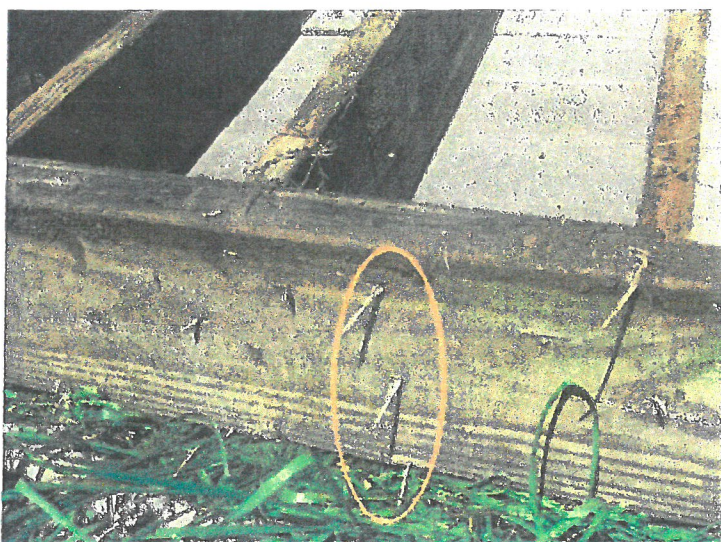
The deck remains shown in Figure 1 depict a case where the deck shifted laterally, away from the structure, and fell to the ground.

Figure 1. Close-up of deck ledger that was connected to a structure with nails only. When lightly loaded by occupants, the deck shifted laterally, pulling the nails out of the supporting structure.

Had the deck fallen vertically at the ledger side of the deck before shifting away from the house, the nails would have bent over. In this case, the nails are essentially straight, indicating that the nails withdrew from the wall before total collapse of the deck floor. Nails used in this application have negligible strength, providing only support for the weight of the deck without sufficient reserve capacity for in-service loading by occupants.

This question can be answered in a few minutes—if *only* nail heads are present on the surface of your deck ledger, you have a nailed-only deck ledger. The deck should be tagged as unsafe, not occupied, and immediately repaired or replaced.

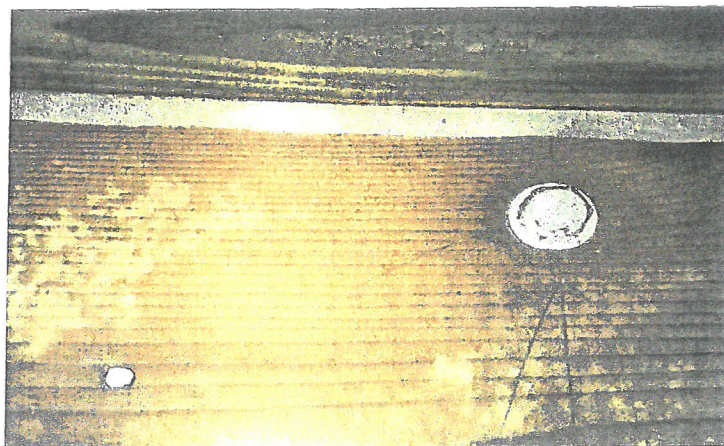
Figure 2. Section of a deck ledger with a nail head and ½" diameter lag screw installed.

The proper lag screw diameter per the IRC can be verified by the fact that  $\frac{1}{2}$ " lag screws have a hex-head that is  $\frac{3}{4}$ " wide. In this case, the contractor used  $\frac{1}{2}$ " diameter lag screws to connect the ledger to the wall sheathing and house band. (The nail (bottom left) was likely used to position the ledger on the wall while the lag screws were installed.)

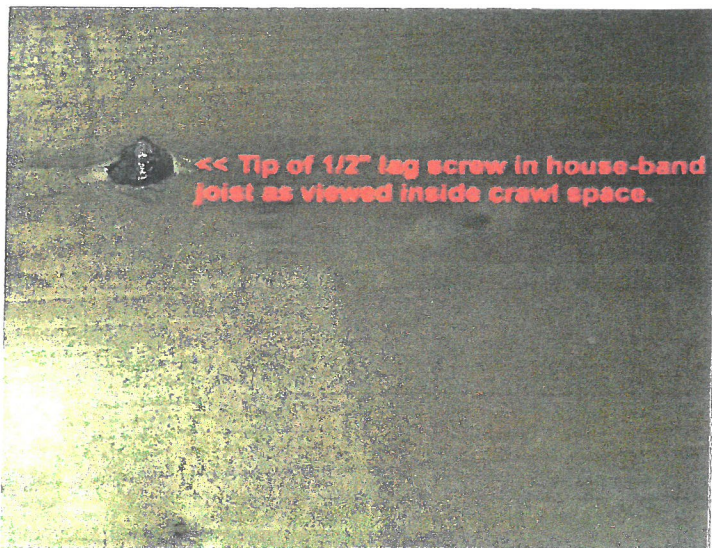
Figure 3. The tip of the lag screw depicted meets the IRC requirement for fully extending beyond the inside face of the band joist.

Because the tip of the screw extends beyond the inside face of the house-band joist, the installed  $\frac{1}{2}$ " lag screw is clearly the proper length as required by the IRC. Assuming the tips of the lag screws are not present, the installation is not
