**ALL  
THINGS  
WOOD**

# Anatomy of an Inherently Dangerous Deck

By Frank Woeste

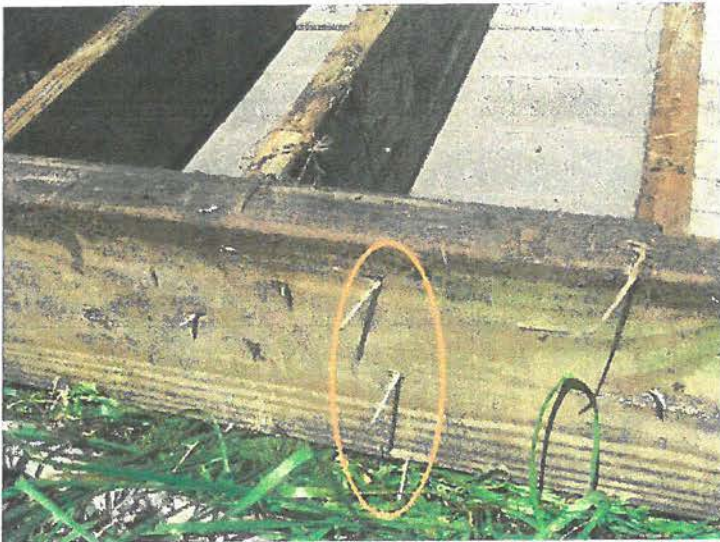
Figure 1. Close-up of deck ledger that was connected to a structure with nails only. When lightly loaded by occupants, the deck shifted laterally, pulling the nails out of the supporting structure.

Had the deck fallen vertically at the ledger side of the deck before shifting away from the house, the nails would have bent over. In this case, the nails are essentially straight, indicating that the nails withdrew from the wall before total collapse of the deck floor. Nails used in this application have negligible strength, providing only support for the weight of the deck without sufficient reserve capacity for in-service loading by occupants.

This question can be answered in a few minutes—if *only* nail heads are present on the surface of your deck ledger, you have a nailed-only deck ledger. The deck should be tagged as unsafe, not occupied, and immediately repaired or replaced.

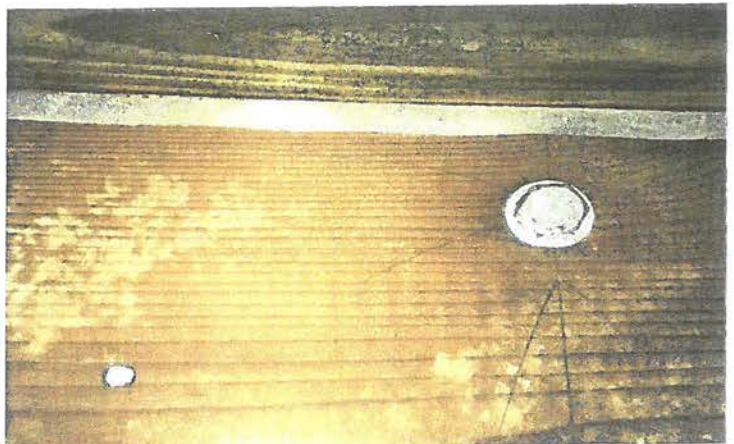
Figure 2. Section of a deck ledger with a nail head and 1/2" diameter lag screw installed.

The proper lag screw diameter per the IRC can be verified by the fact that 1/2" lag screws have a hex-head that is 3/4" wide. In this case, the contractor used 1/2" diameter lag screws to connect the ledger to the wall sheathing and house band. (The nail (bottom left) was likely used to position the ledger on the wall while the lag screws were installed.)

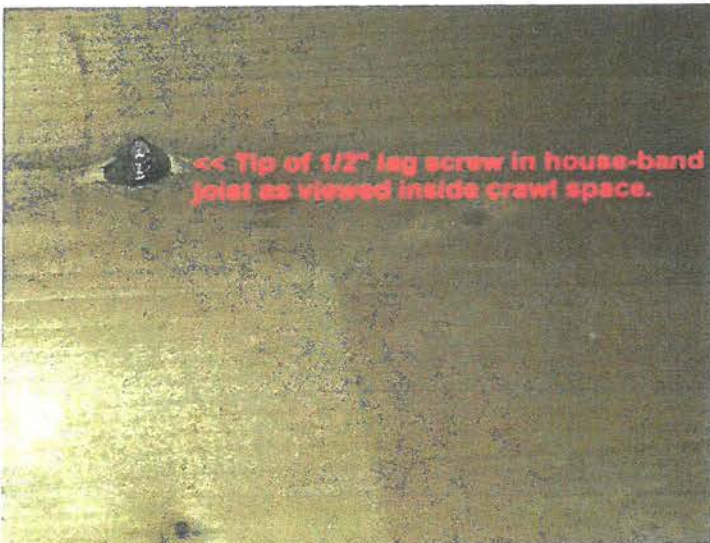
Figure 3. The tip of the lag screw depicted meets the IRC requirement for fully extending beyond the inside face of the band joist.

Because the tip of the screw extends beyond the inside face of the house-band joist, the installed 1/2" lag screw is clearly the proper length as required by the IRC. Assuming the tips of the lag screws are not present, the installation is not
